# Improved grain storage structures

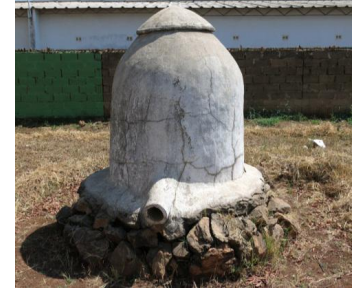
Concrete made bin for grain storage.

- The bin walls are built 1-1.5m high with burnt clay bricks and plastered with either mud or cement mortar although mud bricks may also be used
- A brick-sized chute for removing the grain is set into the first row of the bricks as the walls are built

- The structure is plastered with mud or cement mortar both inside and outside
- The grain is filled into the bin from the opening on top
- The bin is closed with a concrete lid.
